Title: **BOTTOM TERMINATED COMPONENTS – the challenges and solutions**

This paper explores the challenges of reflowing Bottom Terminated Components - referred to as **BTC** and including QFNs (quad flat no leads), LGAs (land grid arrays), DFNs (dual flat no leads), MLF (micro lead-frame)

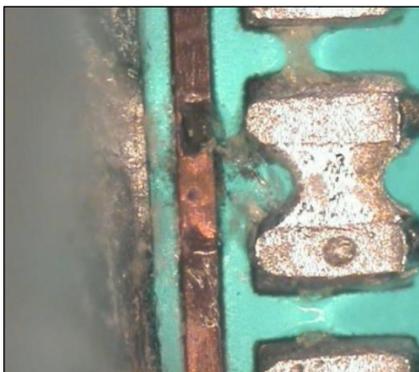
Flux residues with potential to cause shorts & current leakage
